**Re: Taber Post Office
Building Condition Assessment – Structural, Mechanical and Electrical**

The Town of Taber has retained MPE Engineering Ltd. to provide a Structural, Mechanical and Electrical building assessment of the current condition of the Taber Post Office located at 5203 49th Avenue, Taber, Alberta. MPE Engineering has also sub-consulted DeJong Architecture to comment on the Architectural building assessment. The Town has expressed interest in purchasing the Post Office building with the intent of constructing an addition in the adjacent vacant lot for the Town of Taber Fire Station. It would be anticipated that the second floor the current Post Office building would be incorporated into the Fire Station functional use area.

MPE and DeJong have conducted a cursory visual site investigation on January 31, 2019 and have been provided record drawings by the owner to access the overall condition of the building. The site visit was in attendance by Steve Munshaw, Fire Chief; Nathan Cote, Deputy Fire Chief; Jeff DeJong, DeJong Architecture; Calvin van Mulligen, MPE-Structural; Alan Hornberger, MPE-Mechanical; and Peter Goertzen, MPE-Electrical.

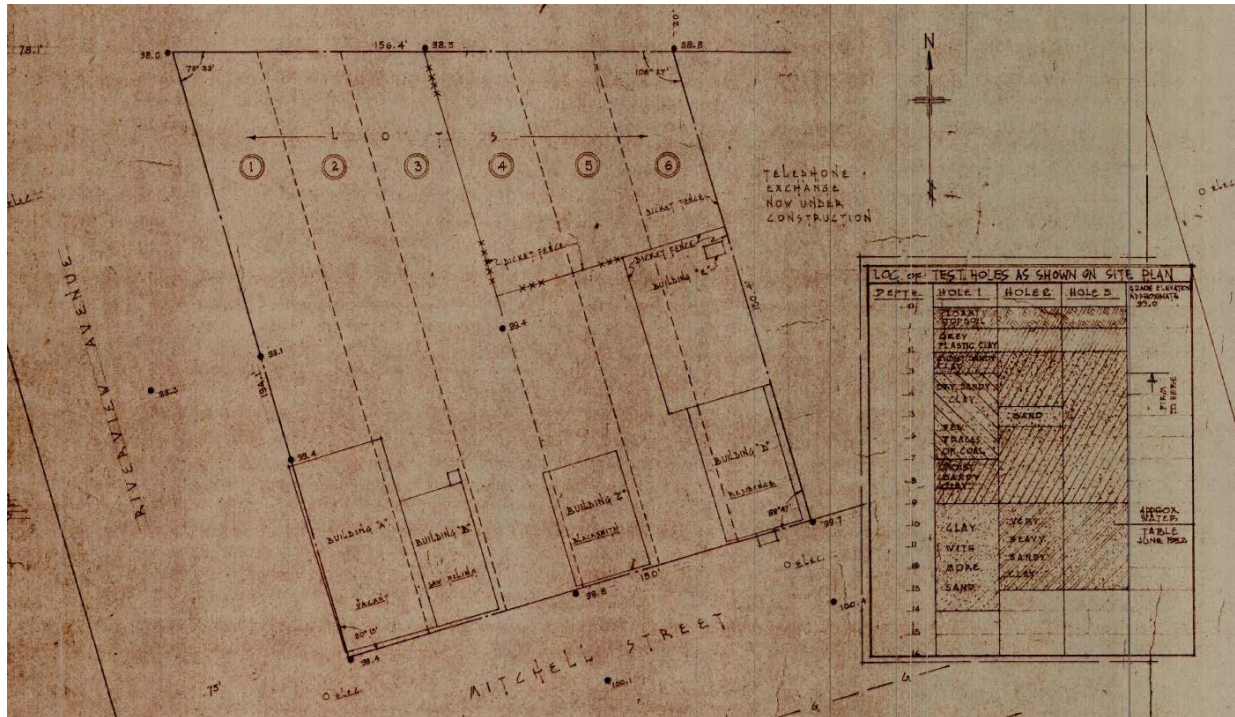
From the record drawings, the soil in the area is approximately 300mm of loam topsoil; 300mm of grey plastic clay; and a mixture of sandy clay which varied within the site. The water table was at 3m below ground. These results for soil are fairly consistent with what is seen throughout the Taber area. A new geotechnical report would be recommended to confirm the results on the record drawings and provide more accurate design values.

There were five buildings on the site south of the current post office which included a vacant building, saw filing, blacksmith, a residence, and a small shed structure. The blacksmith, residence and shed building may affect the foundations depending on what was left behind after the demolition.

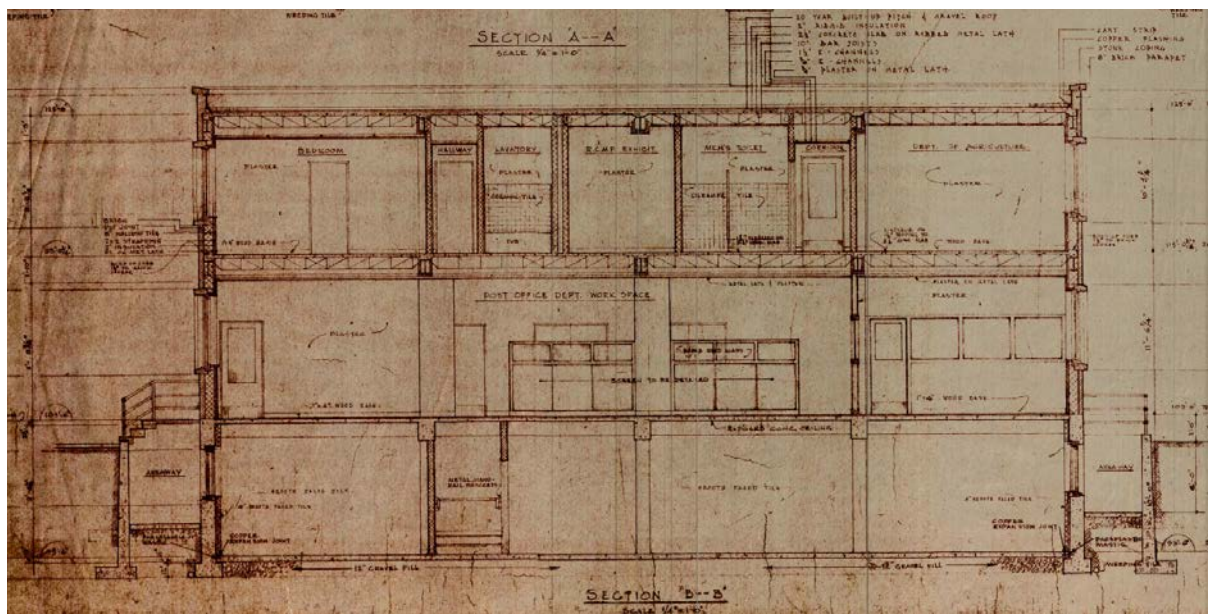
The main superstructure of the Post Office is a structural steel columns and frame with open web steel joist infills. The floor slabs are 65mm concrete structural slab on ribbed metal lath. Overall the main superstructure of the building appears to be performing well under the current conditions.

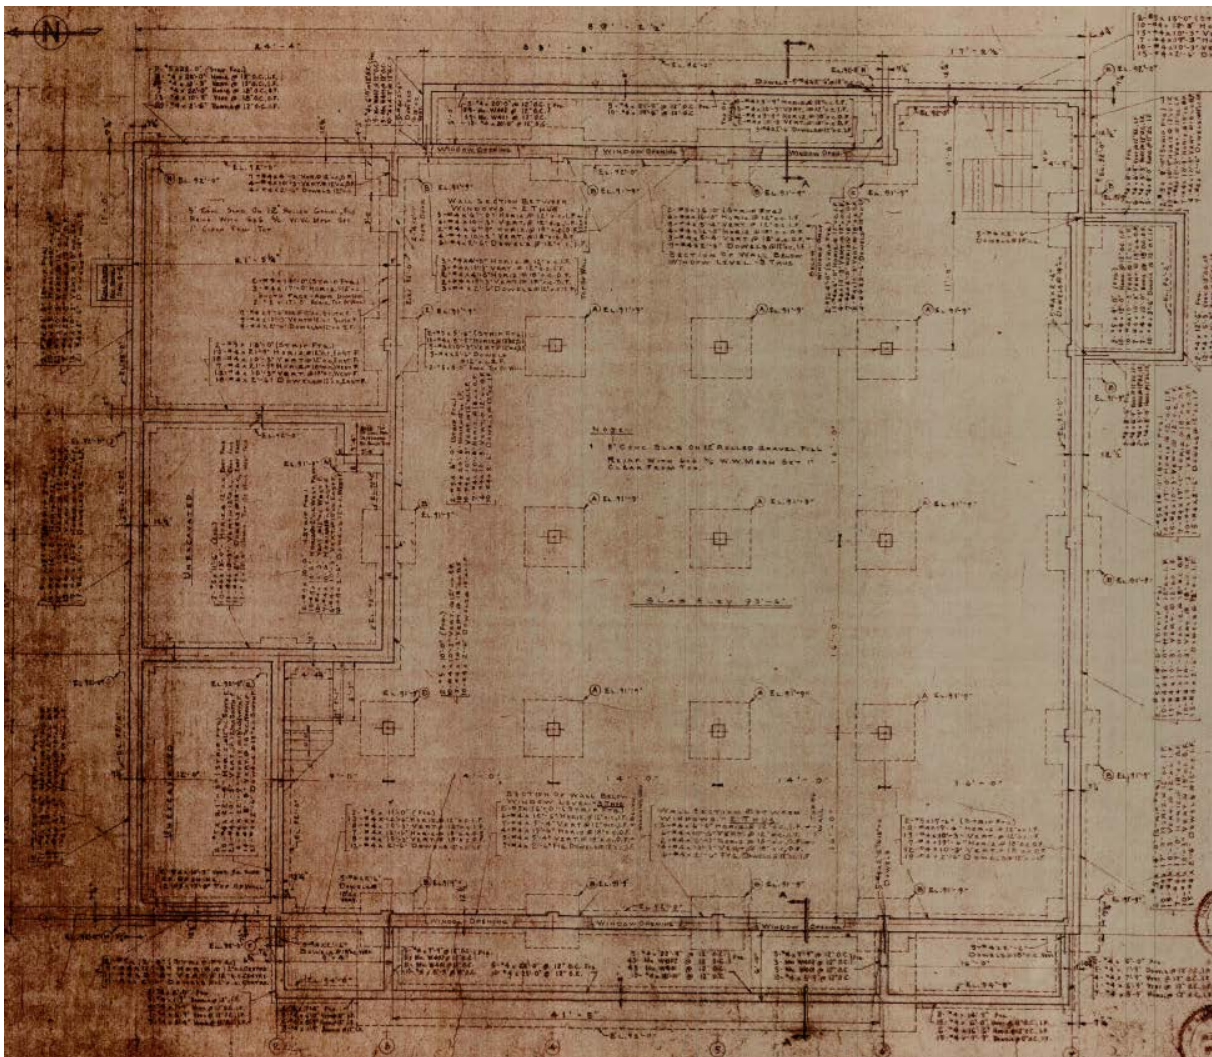
Based upon the record drawings provided, the foundation system for the existing Post Office building is comprised of conventional concrete cast-in-place strip and pad footings. The south portion of the foundation is typical basement construction with walls ranging from 200mm - 300mm thick. The north portion of the foundation is strip foots and unexcavated areas. Columns and pad footings form a standardized grid at 4800mm spacing to support the stories above. The slab on grade is 125mm thick with 300mm of gravel fill. From the site walk through the basement structure was in sound condition and no visible signs of overstressing. Some cosmetic cracks are present in the slab on grade in the mechanical room. These cracks could be fixed at the owner's discretion.

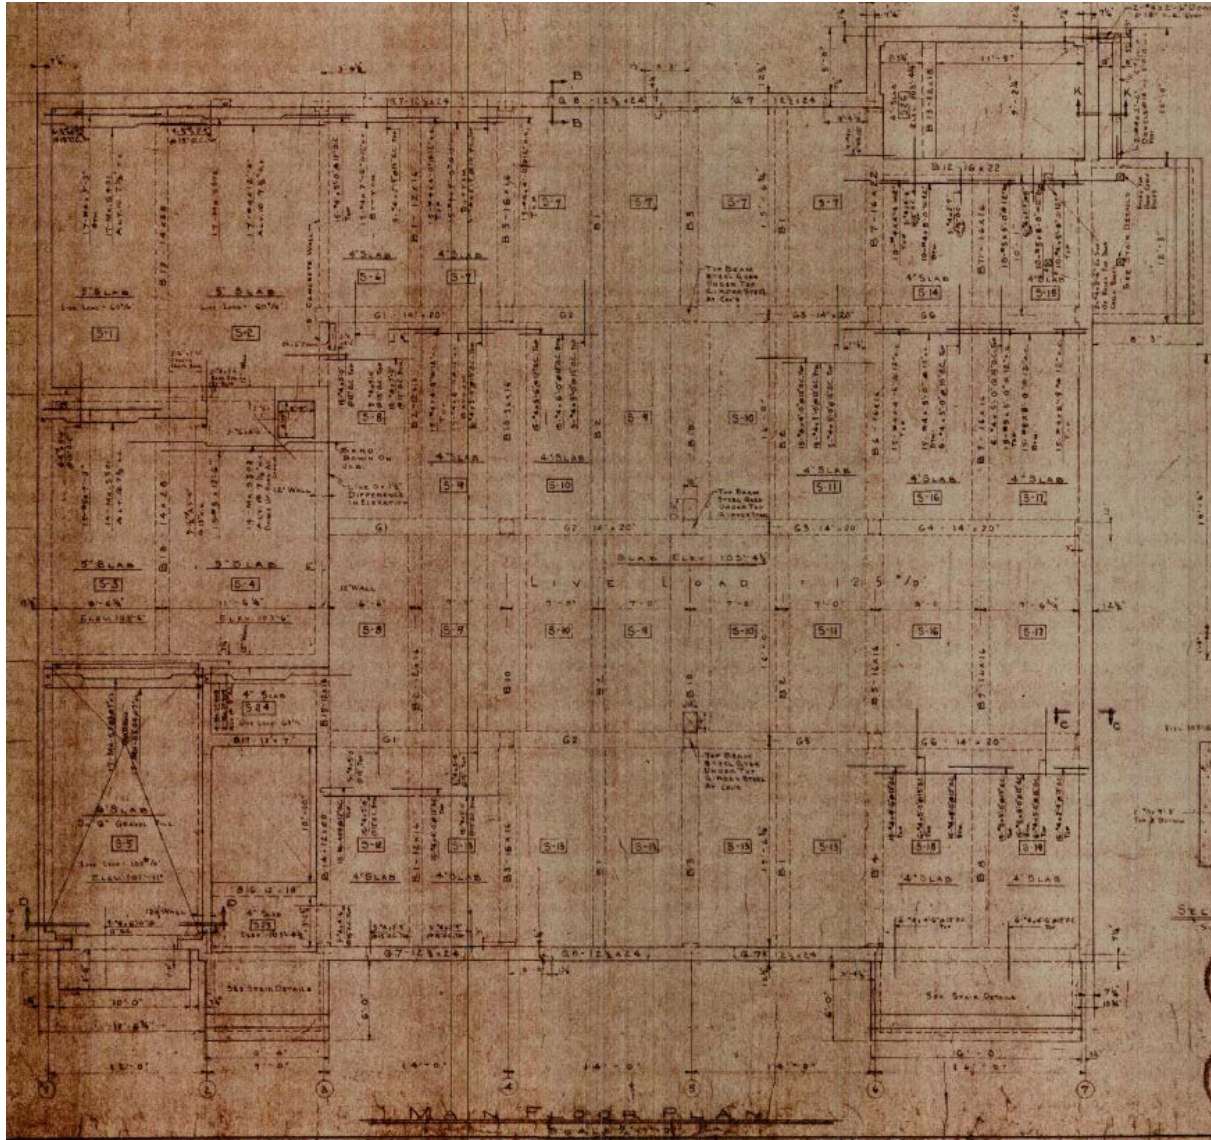
The main floor throughout the building is composed of a structural concrete slab and beams. Overall the main floor structural slabs are performing well based on the age of the structure. The main floor has been occupied by the Post Office since the building's construction. Only minor renovations appear to be present structurally based on the current conditions and the original drawings.

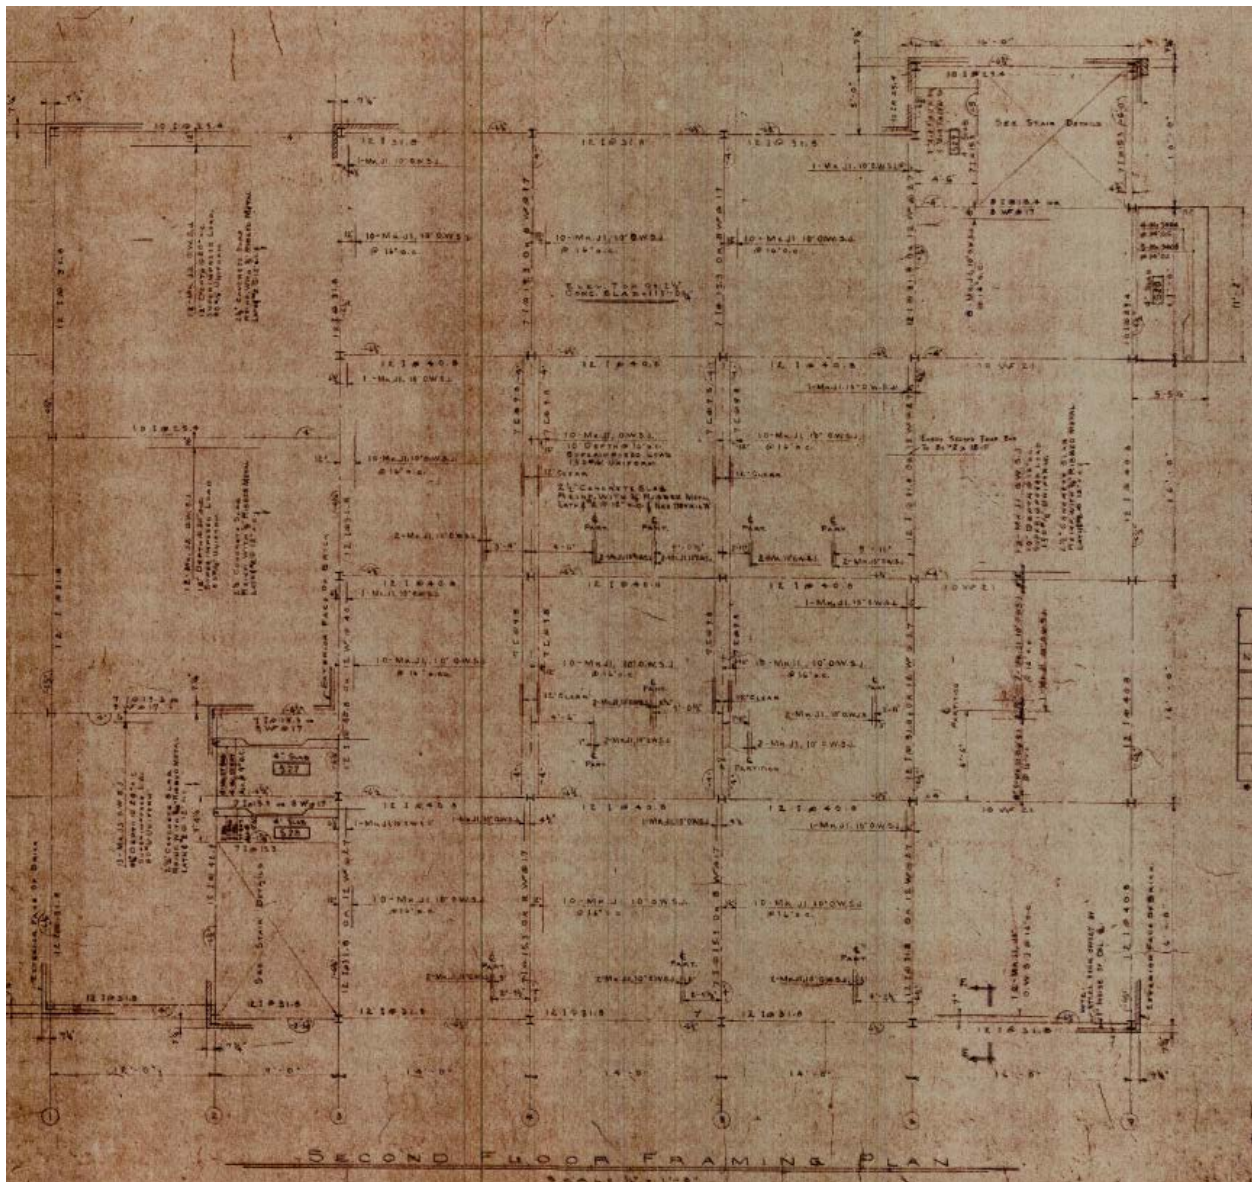
The second floor of the structure is composed of a non-combustible construction system. The structural floor is composed of a 40mm concrete leveling surface, 65mm concrete structural slab on ribbed metal lath, 250mm bar joist, and structural steel beams. The leveling surface was poured after the walls were installed and are not consistent between rooms. If heavy renovations are completed on the second floor with altering wall locations, it would be anticipated that releveling of the floor topping would be required. Overall the second floor appeared to be in sound structural condition. Note that some minor cracks were present in the stairs up to the second floor on the south east stairwell; however, these appear to be cosmetic.

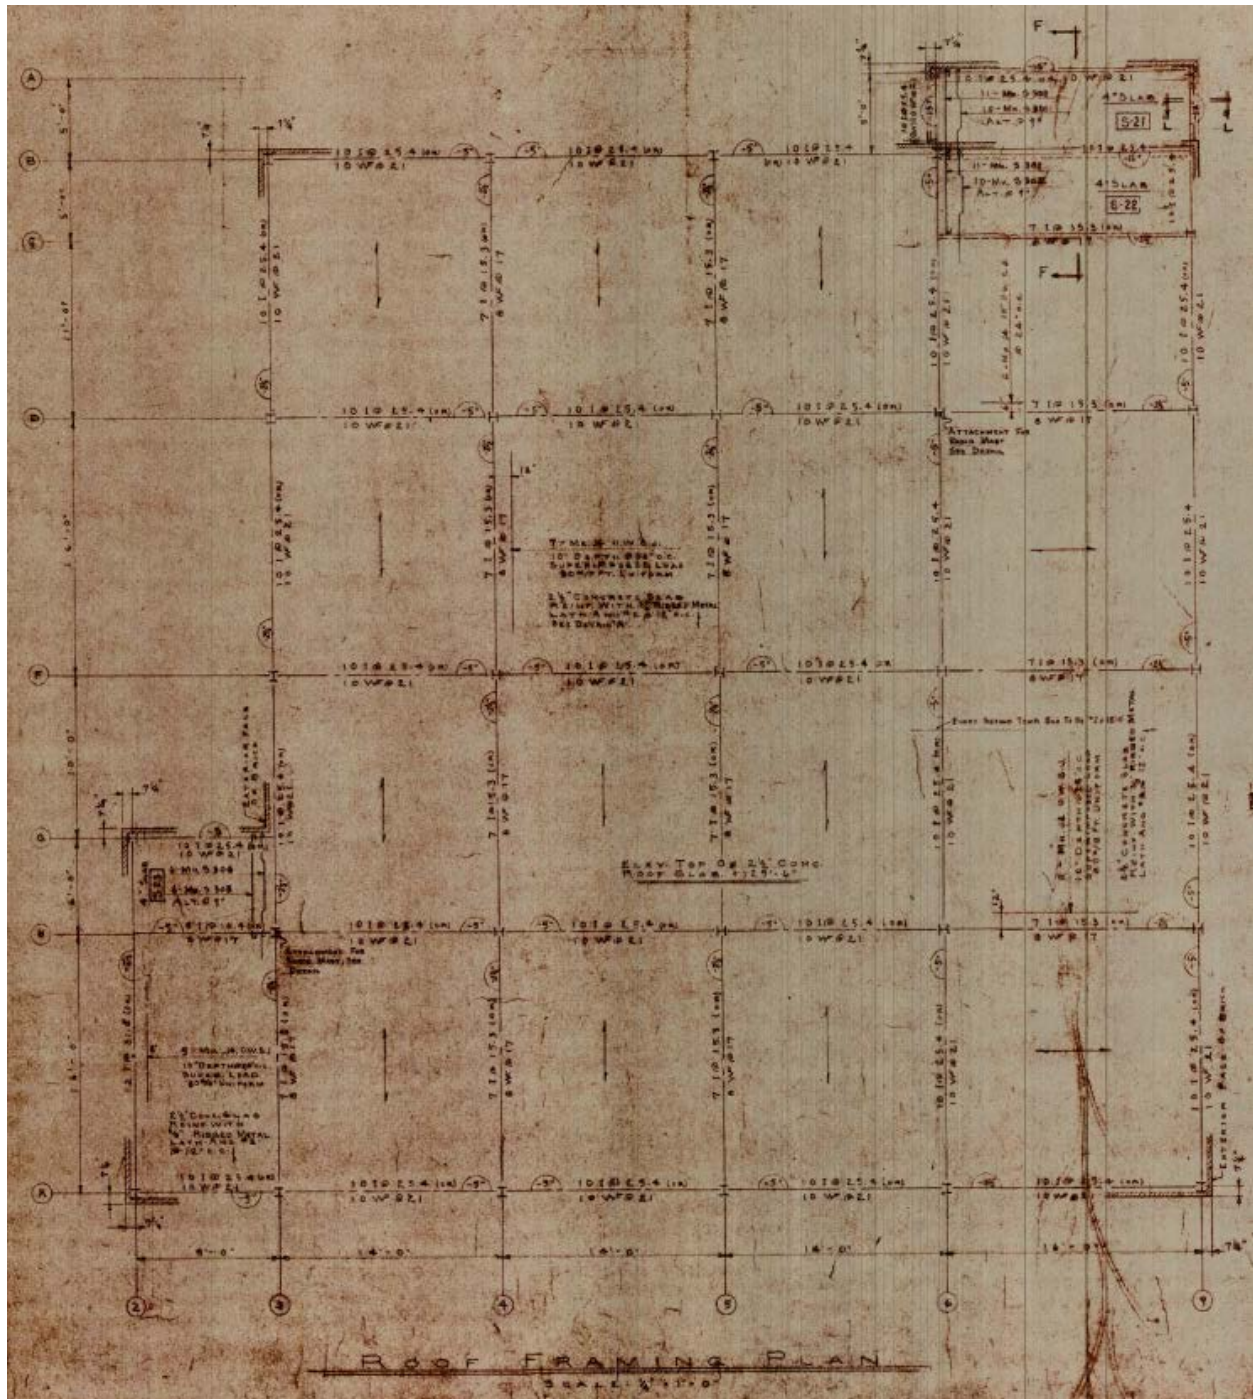
The roof was originally a 20 year built up bond pitch and gravel roof, however, it was recently reroofed in a poly vinyl system. The current roof structure is likely a single ply polyvinyl sheet membrane, 100mm rigid insulation, 65mm concrete slab on ribbed metal lath, 250mm bar joist, and structural steel beams. There was some ponding on the roof at the time of inspection; however, this appear to be due to reroofing.

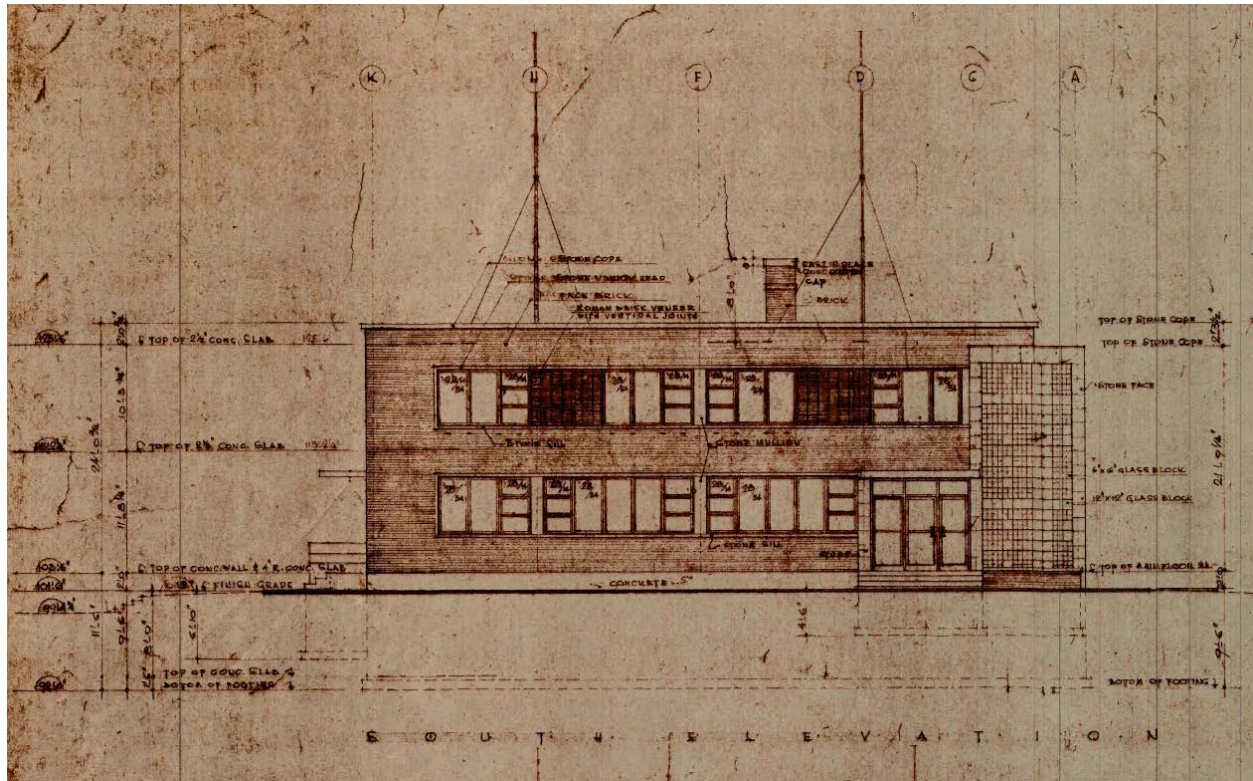
The exterior envelope of the building is typically composed of clay brick, Tyndall stone and glass block which was very common for government buildings at the time of construction. Overall the exterior envelope of the structure is performing well based on the age of the structure. Note that the air tightness and insulation of the building would not be acceptable with current Building Code standards.

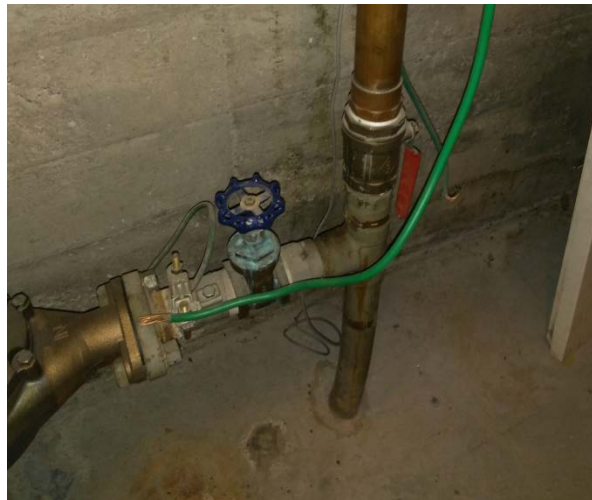
Domestic water is supplied by copper piping throughout, with some pex tubing in newer fixture installations. Piping to the fire hose cabinets is galvanized steel. The water service currently does not have back-flow prevention; this should be added to comply with current plumbing codes. Estimated cost: \$3,000

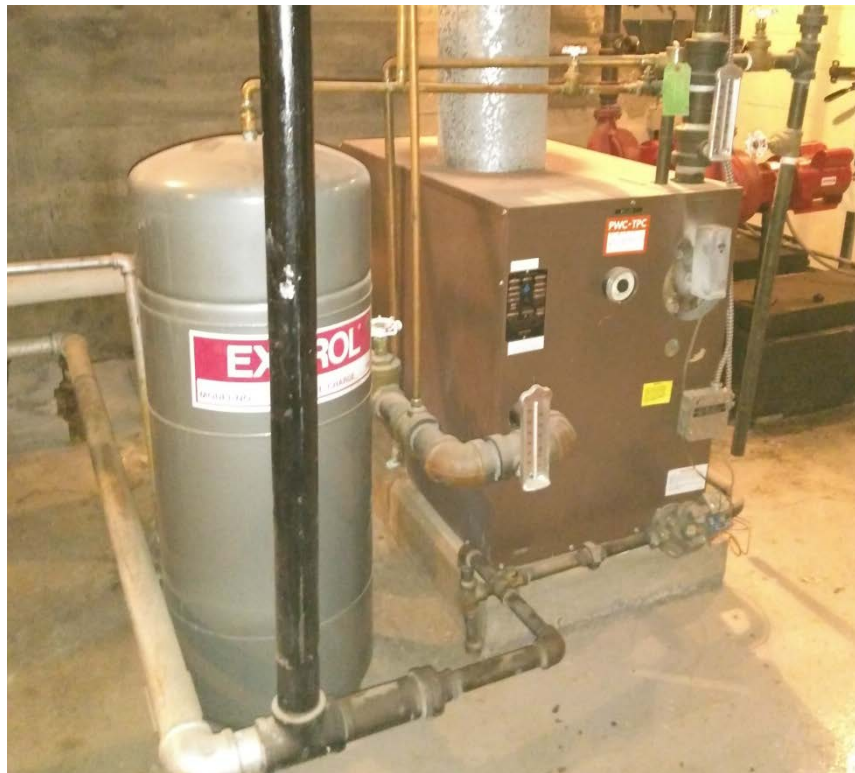
Heating for the building is provided by a hydronic heating system, consisting of two (2) gas-fired boilers with a duplex pumping distribution system. The boilers are past their expected life cycle and should be replaced in the next 5 years or less. Estimated cost: \$50,000

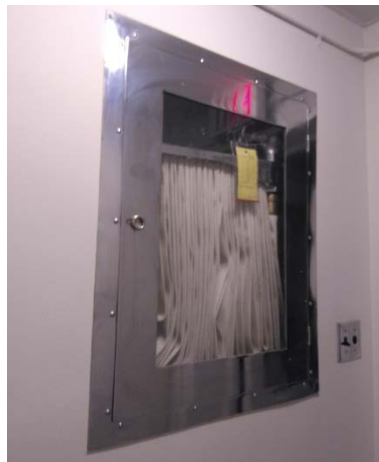
Hand-held fire extinguishers and hose cabinets are installed throughout the building, with sufficient coverage. Hose cabinets should be decommissioned and replaced with additional hand-extinguishers as required for sufficient coverage. Estimated long-term cost: \$5,000

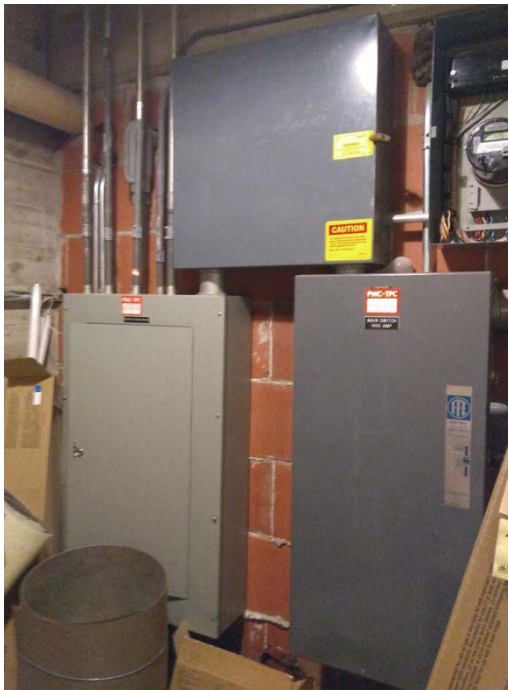
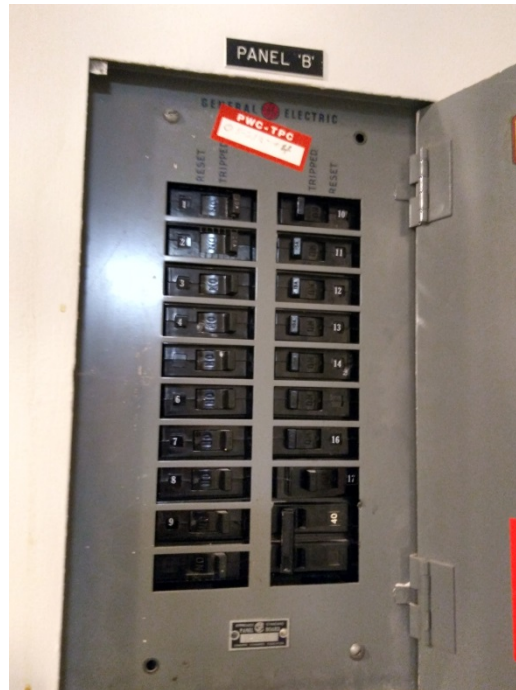
Electrical service is provided from the east side of the building overhead from a pole mount utility transformer and runs through the building to the electrical room in the basement on the west side. This needs to be relocated to meet current electrical codes for the maximum allowable length of a service line inside a building. Estimated Cost: \$35,000

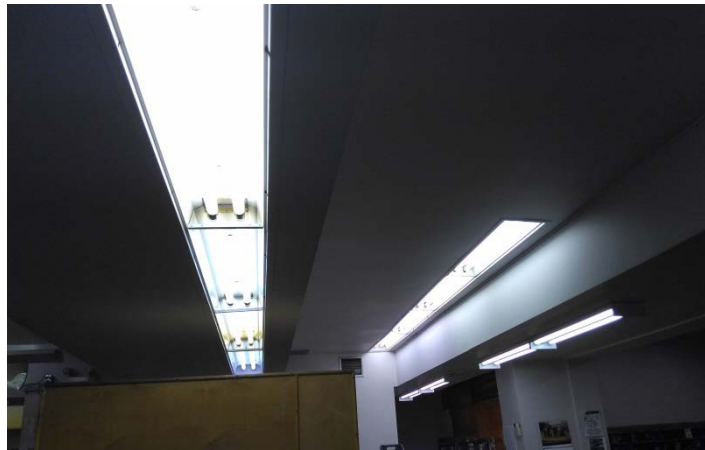
Interior lighting is a mix of fluorescent T-12 and medium base incandescent fixtures. Lighting levels appear to be acceptable. Lighting upgrades should be considered to maximize energy efficiency and reduce maintenance costs. Estimated long-term cost: \$50,000

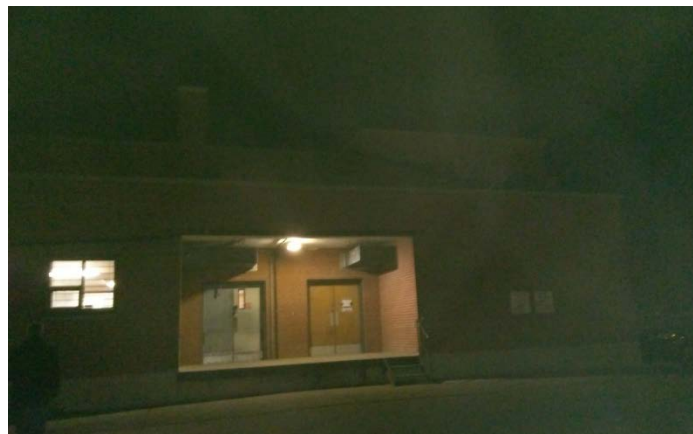
Exterior lighting provides only coverage outside the entrance area. Additional fixtures should be added for improved security. Estimated cost: \$6,000

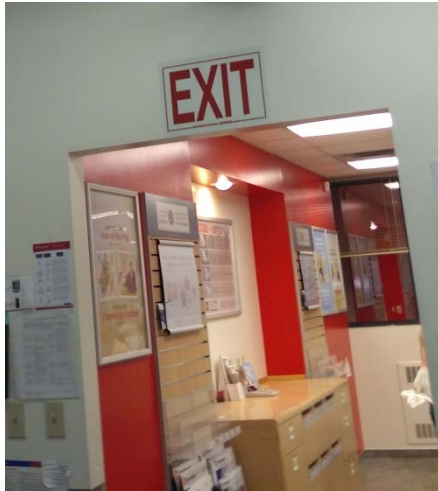
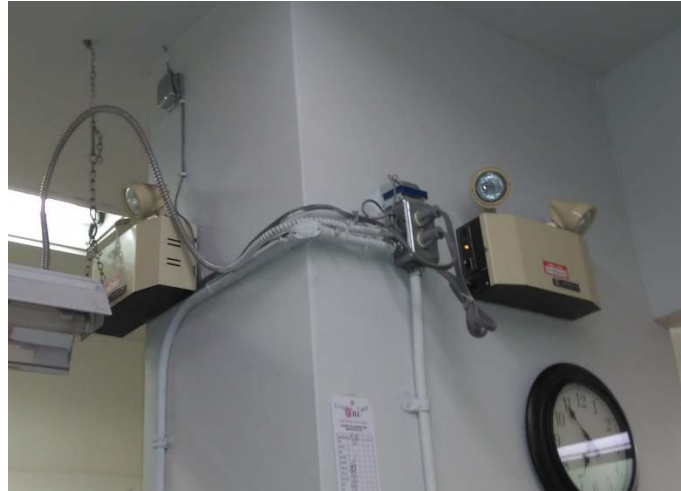
Exit signage and lights are incandescent and several are burnt out and do not appear to be self-powered. There is reasonable coverage throughout building. It is recommended to replace with self-powered units. Estimated cost: \$15,000

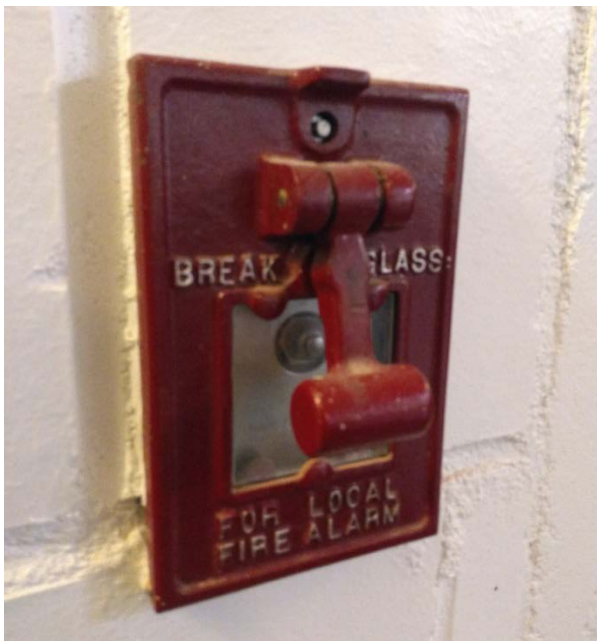
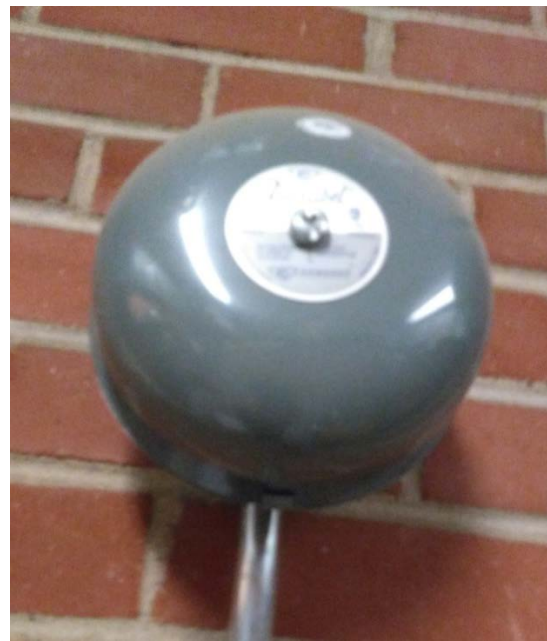
The fire alarm panel is dated and the building fire alarm system and devices appear to be original to the building. This should be upgraded to a modern addressable system. Estimated cost: \$60,000

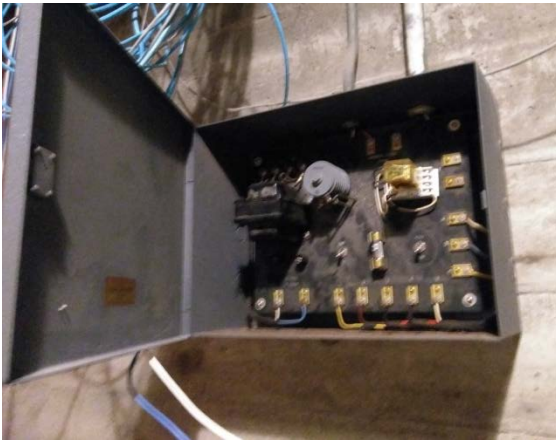
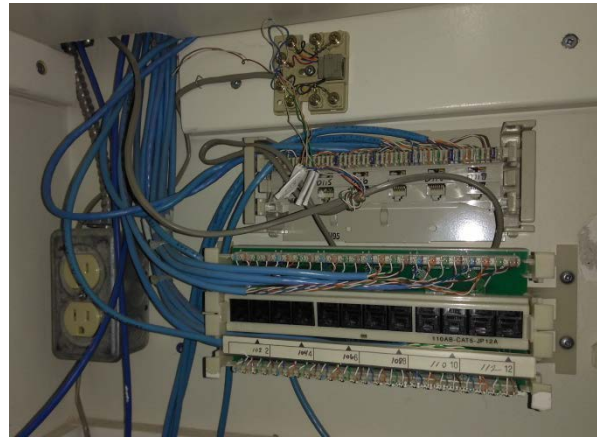
Telephone system includes basic phone components, CAT-3 main lines and a mix of CAT-5 and CAT-3 cables. There is limited coverage for Wi-Fi and distributed networking. This should be upgraded if usage of residences is changed for Fire Department requirements. Estimated cost: \$25,000

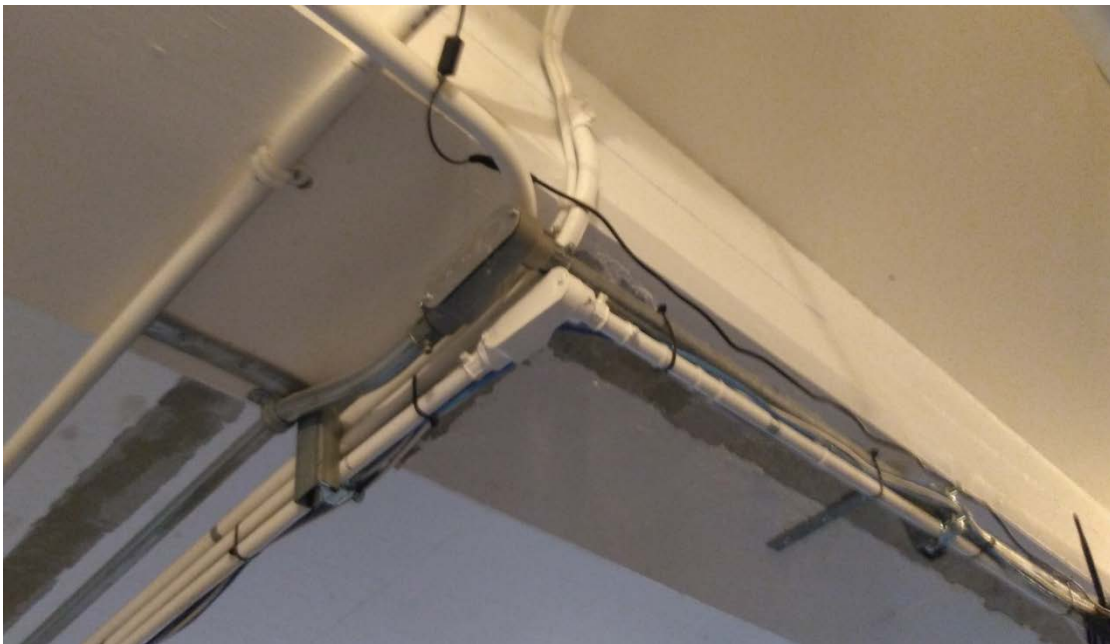
Local network system and equipment should be upgraded for potential building usage changes, as well as installing protection for exposed existing network cable. Estimated long-term cost \$30,000

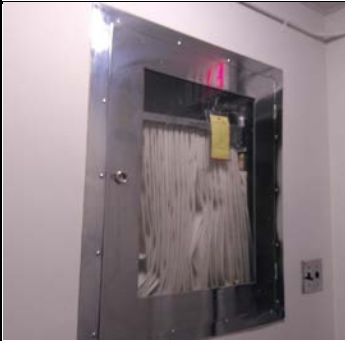
4.2.2	Fire suppression systems (i.e., pumps, sprinklers, piping, reservoirs, hoses, stand pipes, CO2 systems).	3

Hose cabinets located throughout. Hoses should be decommissioned and replaced with hand extinguishers.	\$ 5,000.00

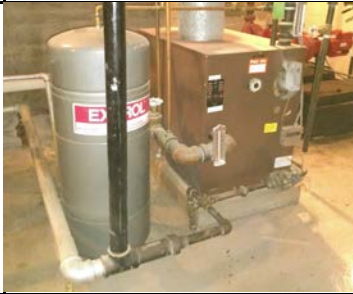
Section 4	Mechanical Systems	Rating	Photo	Description/Condition	Estim. Cost
4.4	Heating Systems				
4.4.1	Heating capacity and reliability (including backup capacity).	2

Hydronic system heated by two (2) natural gas fired boilers, 1,664 MBH total heating output capacity, located in basement mechanical room. Boilers look to be past their expected life cycle and should be replaced in less than 5 years.	\$ 50,000.00
