Town of Taber
Recreation Master Plan
Research Report

December 2019

Taber Community Centre and Aquafun Centre Facilities Analysis Report

**Community Centre: Large Ice Arena, Small Ice Arena, Curling Rink, Auditorium,
Downstairs Fitness Space and Archery Range,
and Aquafun Centre**

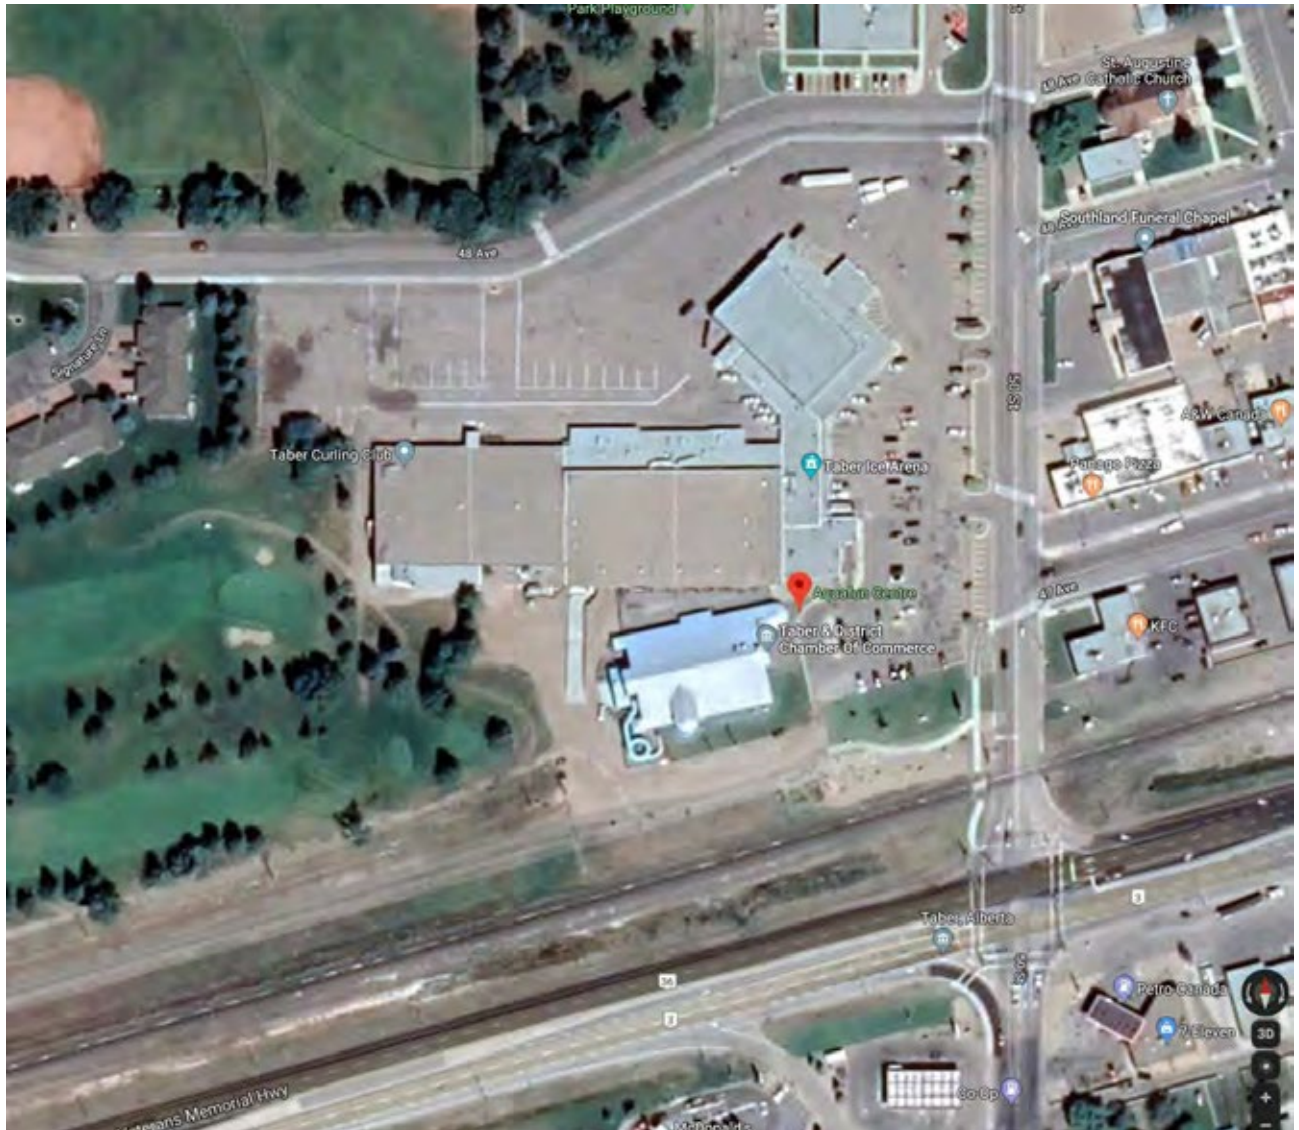
FIGURE 001

The Town of Taber built the original Community Centre in 1970 with renovations. The whole site is provided by a Google Earth image. (See figure 001) The Arena is classified as an A-3 occupancy and is approximately 9000 m². The building structures have been maintained and are in still in acceptable condition. A cost should be evaluated for the noted code deficiencies. The building envelope and insulation should be further investigated to confirm the thermal performance of the building with new code requirements. Further investigation of the mechanical and electrical components is recommended to understand if existing systems should be renovated or replaced. Equipment and service costs have not been factored into the following pricing. Further discussion is recommended on the building's long-term viability with the population of the region.

Original roof construction was gravel ballast on tar. Roofs for the Auditorium, Arena entrance, Museum and over the change rooms have been replaced with 2-ply SBS roof system. (See Figure 001) Other roofs are being scheduled for replacement.

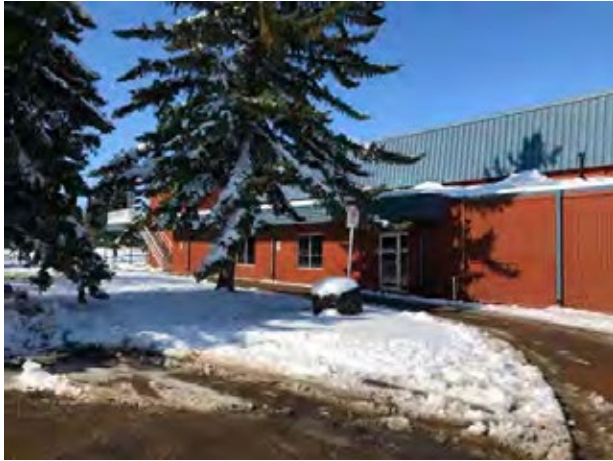
FIGURE 002

The north, east, south and some of the west sides of the buildings are paved. There is a fire lane around the south and west sides of the building that is gravel. (See Figures 002 and 003) The Aquafun Centre has green space on the south and east sides with some small trees on the west side. (See Figures 004 & 005) A space between the Community Centre and Aquafun Centre is used to store equipment from the Museum. (See Figure 006)

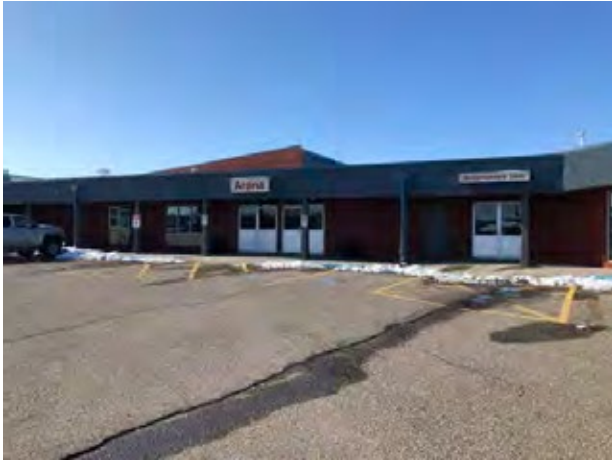
FIGURE 008

The east side of the building is the main access off of 50 Street. Access to the Large Arena, Downstairs Fitness Space, Museum and Chamber of Commerce is along the east face of the building. (See Figures 007 & 008) Museum and Chamber of Commerce was not reviewed.

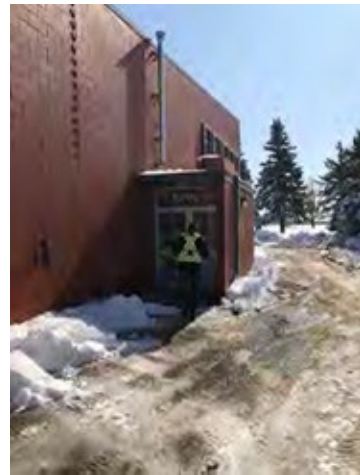
FIGURE 011

The west side of the building backs onto a golf course. The access into the curling rink is along the west with parking in the north side of site (See Figure 011)

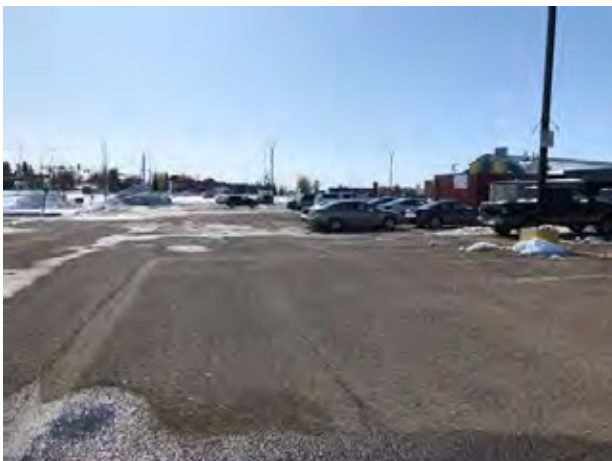
FIGURE 012

The parking lot was mostly cleared of snow and appeared to drain with evidence of shallow puddles near the Auditorium overhead door, the north and east parking lots (See Figures 012). Different degrees of cracking pavement was noted throughout. (See Figures 013)

The parking lot was indicated to be considered for next year's funding for repair/replacement.

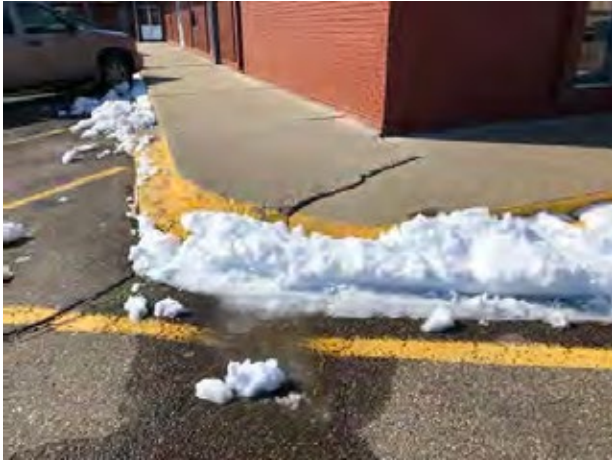
FIGURE 014

The grading against the Community Centre is hardscape, mostly paving and concrete sidewalks. Where snow was still present, grading could not be confirmed. Sidewalks were noted as cracking and being damaged along the squared edges. Paint is flaking off. (See Figure 014)

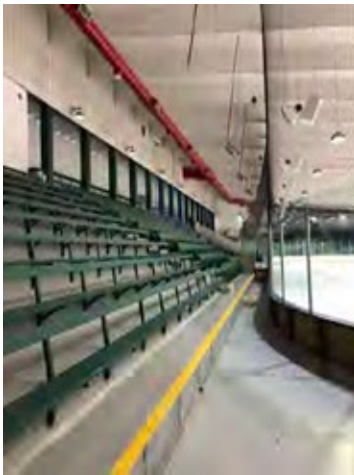
FIGURE 016

Concrete seating and slab are cracking. (See figures 016, 017& 018)

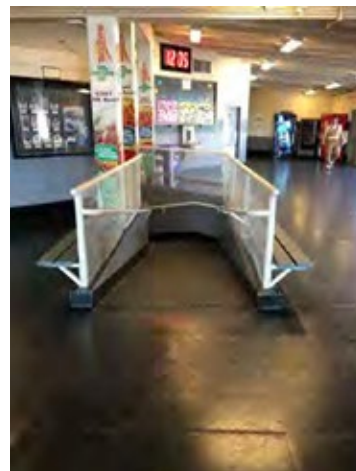
FIGURE 019

A ramp is provided from the main lobby into the large ice arena for skaters to access the ice from the public change rooms. This currently does not meet barrier-free accessibility requirements and the door exits in the wrong direction. This entrance should not be used by the general public. (See figures 019 & 020)

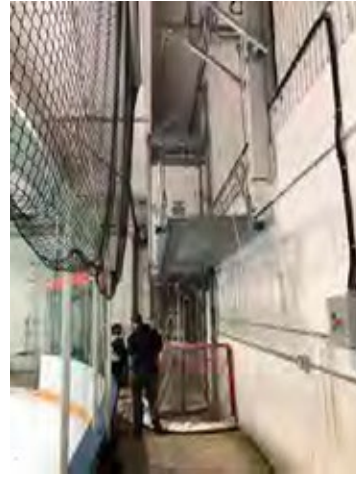
FIGURE 021

A wood boardwalk is provided near the ice plant. (see figure 021)

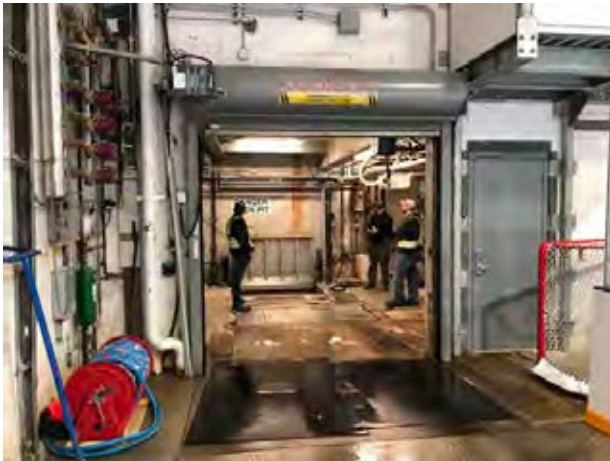
FIGURE 022

The Zamboni storage has two overhead doors, one to the exterior, one to the ice. The interior door is a fire shutter and there is a rated man door. (See figure 022)

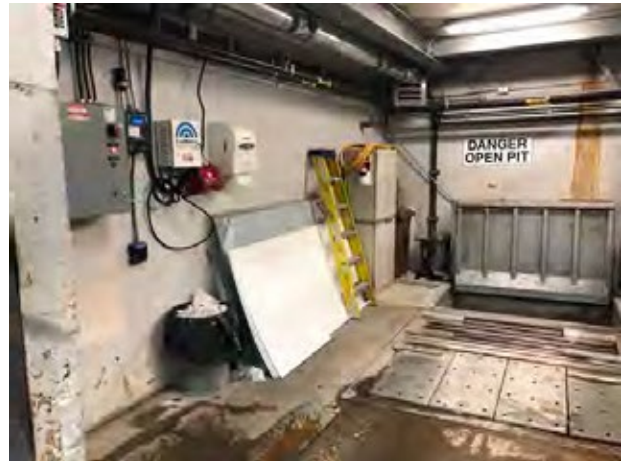
FIGURE 023

Zamboni has heated dump pits to help melt the ice. (See figure 023)

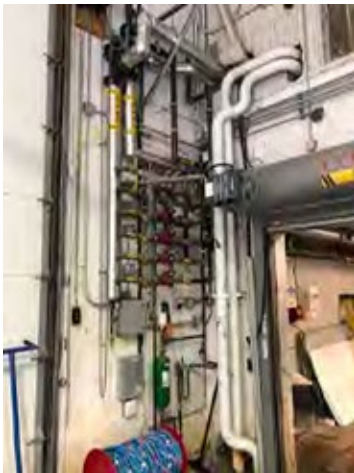
FIGURE 024

The Zamboni space also has the glycol system, boilers and Super Hot tanks around it. Tanks were noted to be over 12 years old and are rusting. (See figures 024 & 025)

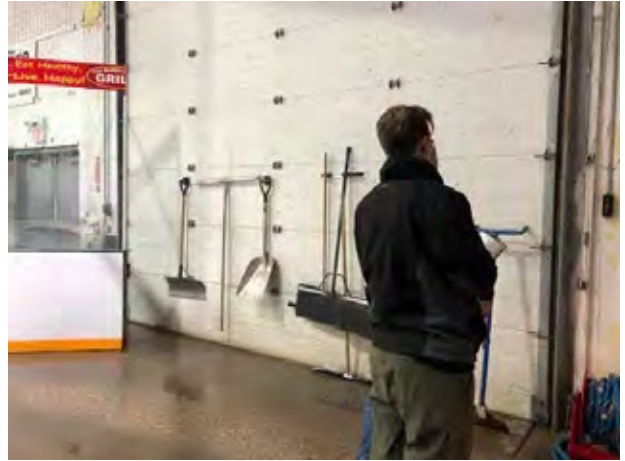
FIGURE 027

Interior overhead doors are damaged due to pucks practice from the users. (See figure 027)

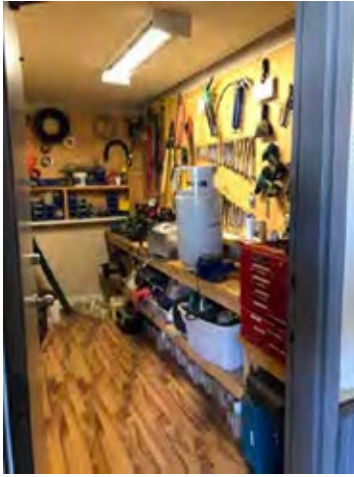
FIGURE 037

Original ticket booth room has been repurposed for operations and maintenance staff. (See figure 037 & 038)

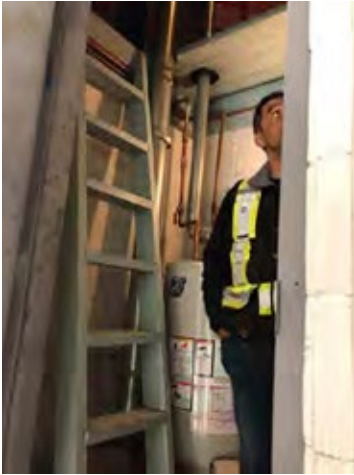
FIGURE 043

Old dressing rooms have air grille at base of floor directly into corridor. (See figure 043)

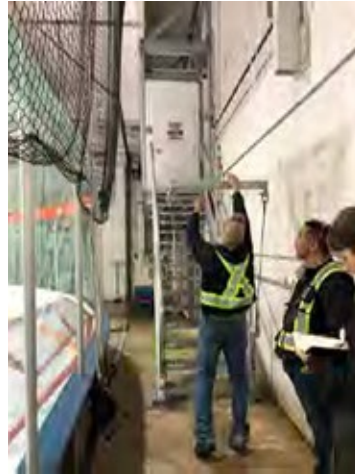
FIGURE 044

The mechanical room contains area for filter replacement and tanks for showers. Sealant is missing in the mechanical room. (See figure 044)

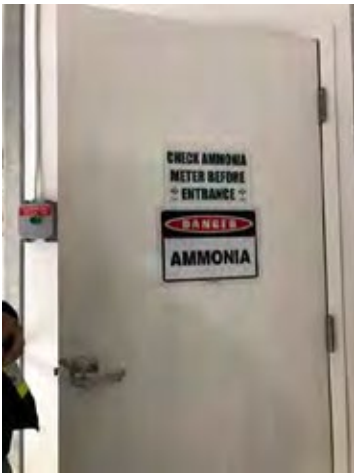
FIGURE 045

The ice plant services the large, small and curling rinks and is located above the large ice rink by mechanically motorized retractable stairs. (See figure 045) The stairs have issues descending if not operated correctly and then need to be reset. Recommend tune up to system to operate intuitively. It can also be accessed from the exterior, near the Zamboni ramp. (See figure 046)

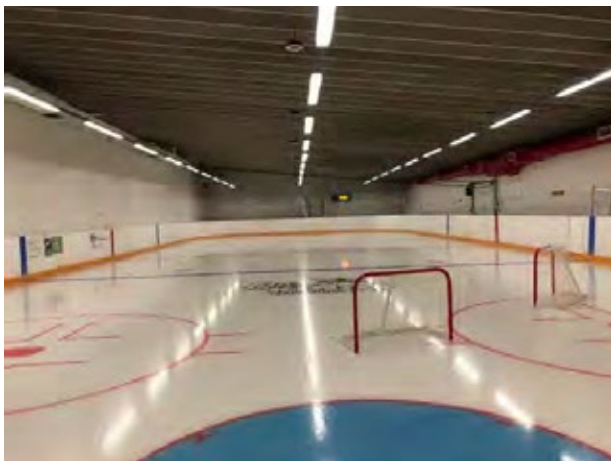
FIGURE 047

The small arena is noted for youth and public skating. (See figure 047)

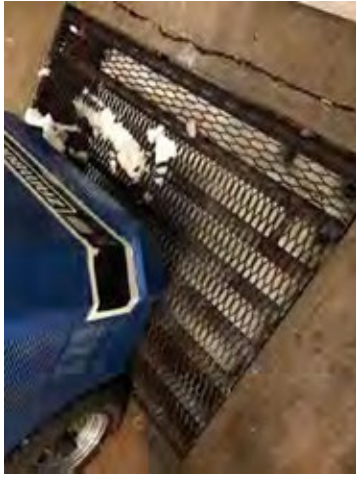
FIGURE 049

The ice does not have a heating system. Ice is dumped into a floor tank and must be manually melted. (See figure 049)

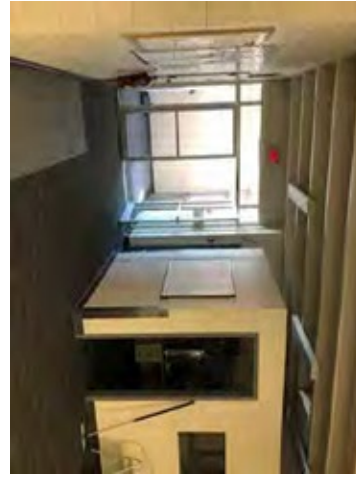
FIGURE 050

Access to the building is by the gravel fire lane around the west side. The doors are double acting. Maintenance is having issues with getting parts. Number of exits to the space is adequate for its use. (See figure 050)

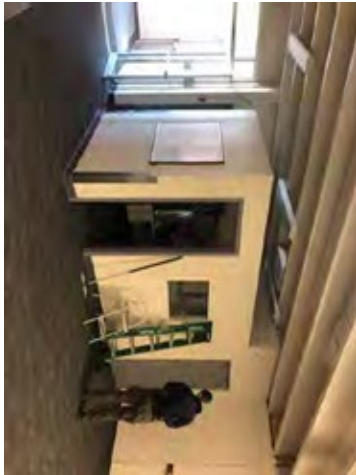
FIGURE 051

An office in the lobby has sliding glazing without a frame. (See figure 051)

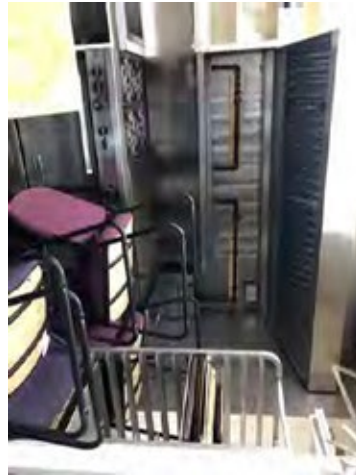
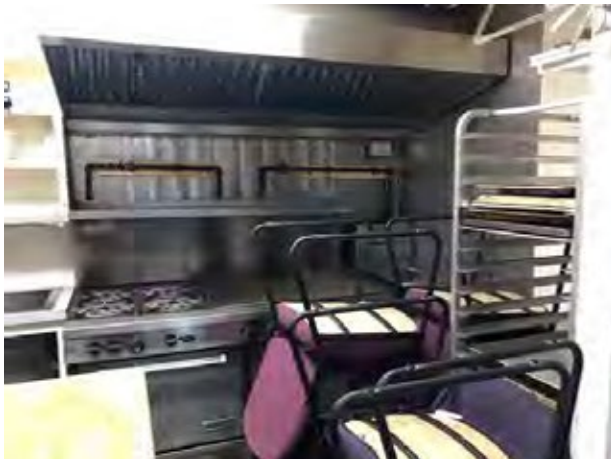
The concession has commercial stove and refrigeration for food sales and is leased out. The lounge and kitchen floors were not renovated. Public Works confirmed no asbestos is present in the flooring in this area. (See figures 052 & 053)

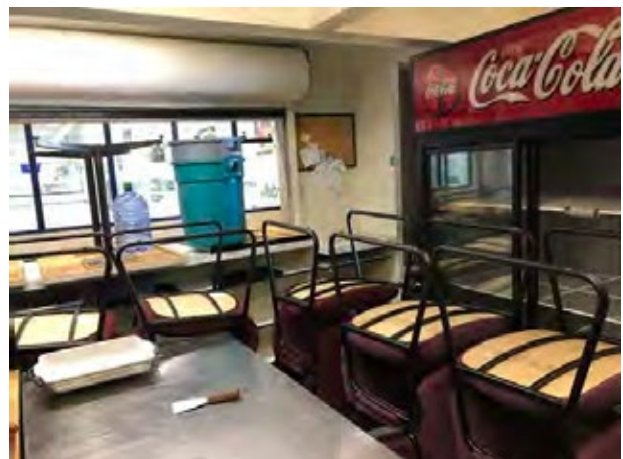
FIGURE 054

Lighting is scheduled to be updated in the space. The sheets are a bit dark. Lighting levels to be confirmed with height lights are mounted. (See figure 054)

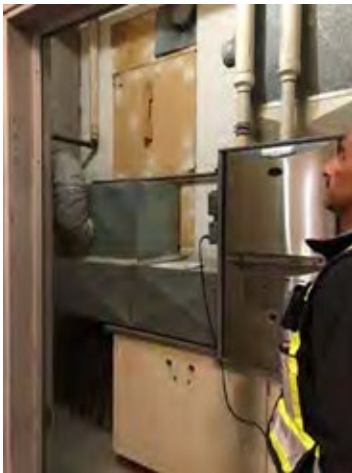
FIGURE 065

A ramp to an overhead door is present in the mechanical space area. It exits out beside the ice plant and cooling tower (Startec). (See figure 065)

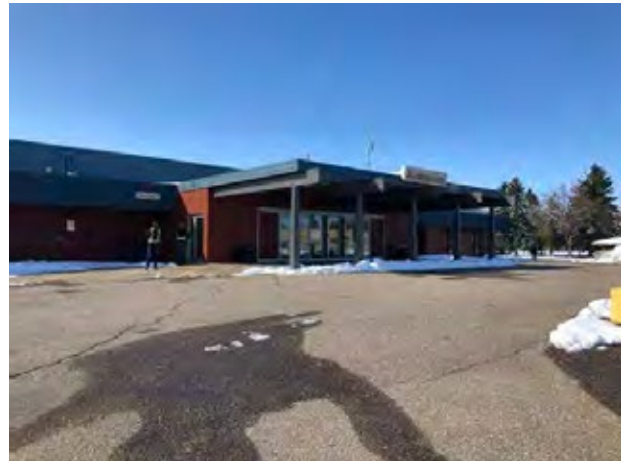
FIGURE 100

Concrete posts are supporting the arena soffit. (See Figure 100)

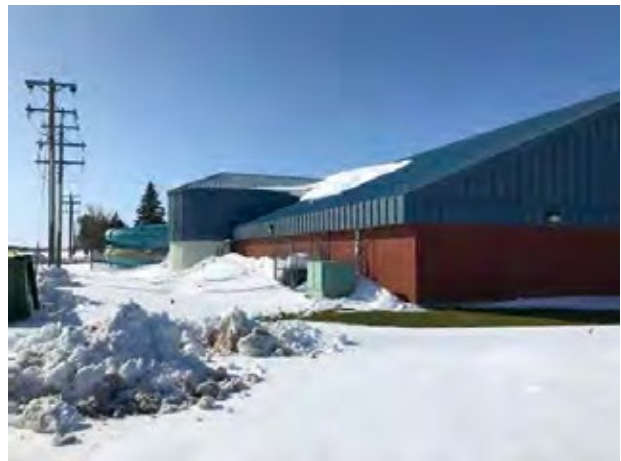
FIGURE 106

The north side of the building is closed off for exterior exhibits from the adjacent museum. (See figure 106) No access is provided from this building.

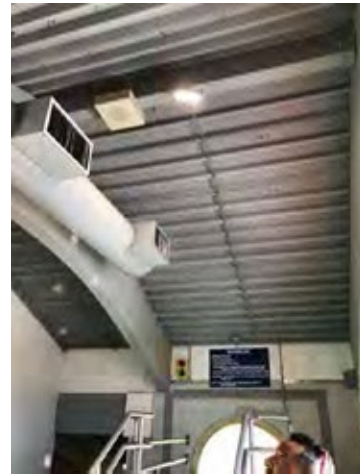
FIGURE 108

The building appears to have lighting provided on the west, south and east walls. The building was not reviewed at night to see if lighting was adequate. The lighting on the canopy appears to be old technology. (See figure 108) Two street light fixtures in the parking area are noted to be owned by others.

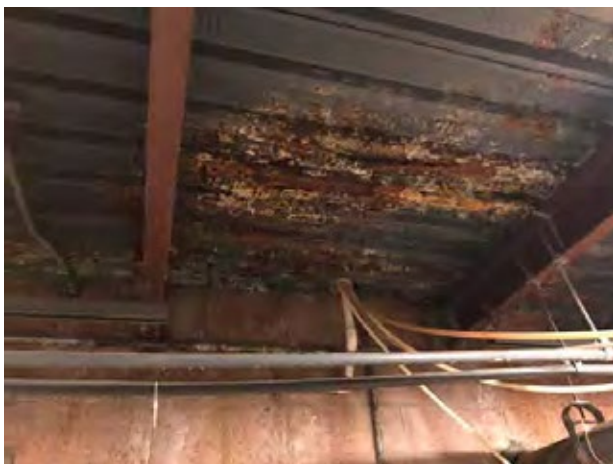
FIGURE 113

Mezzanine in Mechanical Room: Stairs lead up and down from the door entry. No sprinklers are present and the mezzanine floor structure between the lower and upper levels of mechanical space is a concrete slab on steel deck. The steel deck is currently rusting. (See Figures 113 and 114)

The mezzanine steel deck with concrete slab in the mechanical has large areas of rust and a segment of missing steel deck. (See figure 113&114)

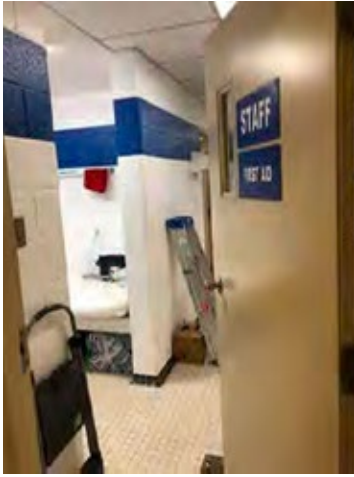
FIGURE 115

The guard station is well constructed and has no dead spaces from view. (See figure 115)

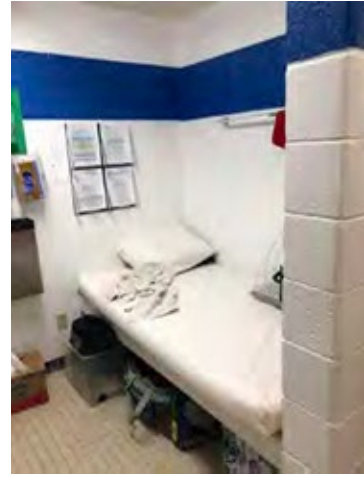
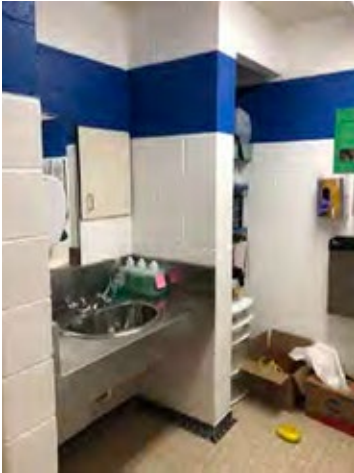
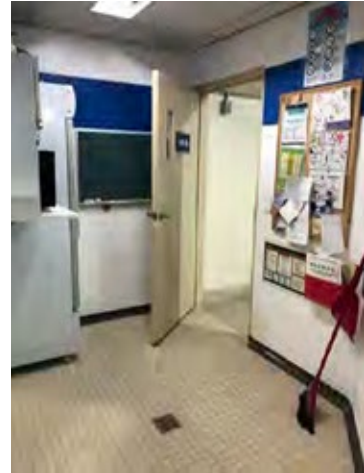
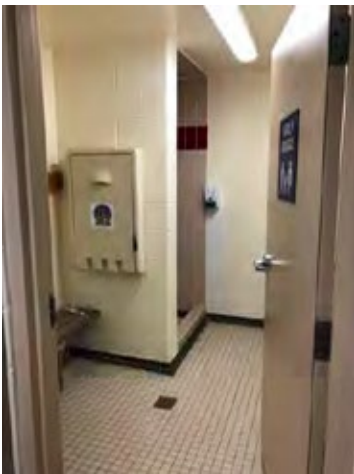
First Aid office is attached to the guard station. Guard area has man and woman change and shower spaces. (See figures 116, 117, 118 & 119)

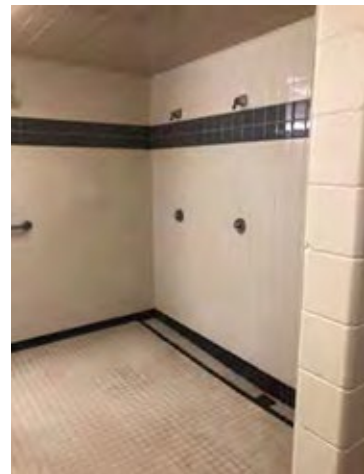
FIGURE 120

Change rooms are provided for women, men, three families and accessibility. Family change rooms are equipped with baby change stations. (See figure 120)

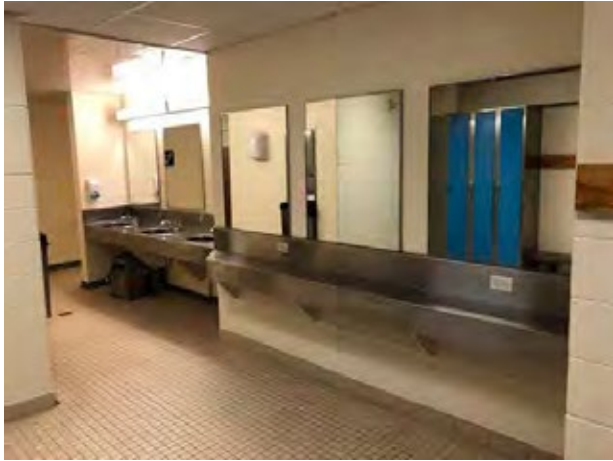
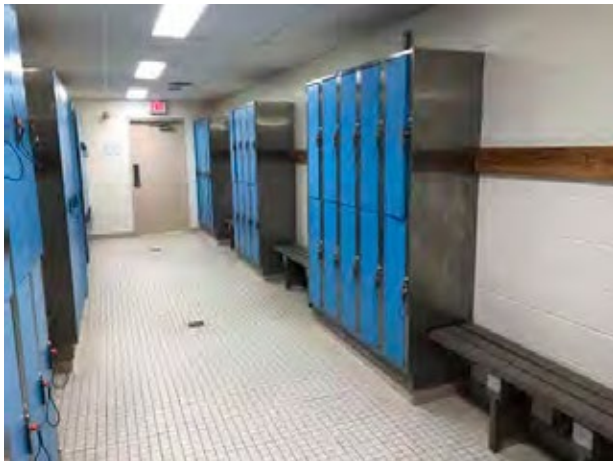
Change rooms contain showers, stainless steel millwork, metal lockers, phenolic washroom partitions, and benches made from composite material to be water resistant. (See figures 121,122,123 & 124) Family change rooms share lockers in the corridor space to each room.

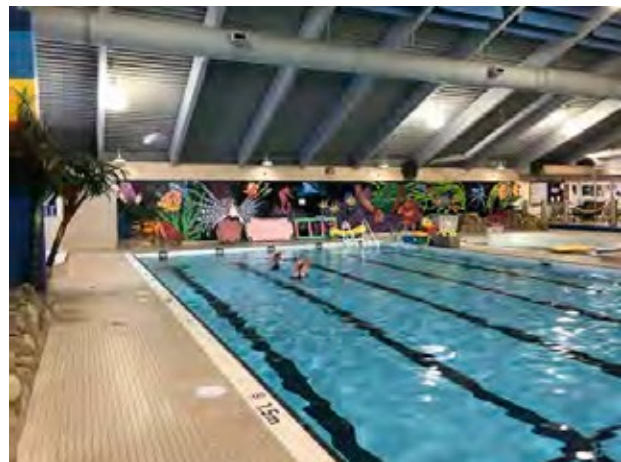
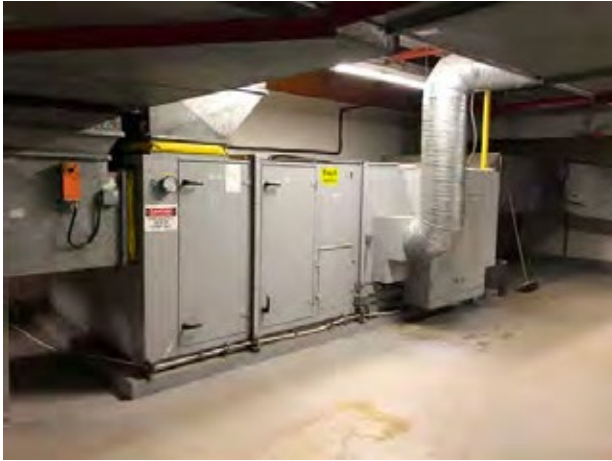
FIGURE 126

Visual art walls and rock assemblies are provided in the swimming area. (See figure 126 & 127)

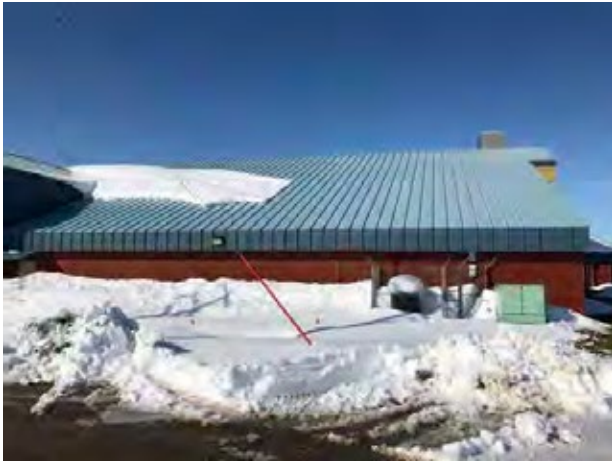
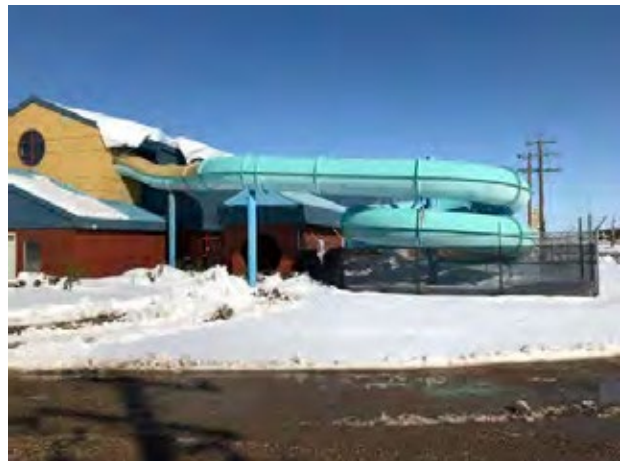
FIGURE 129

The metal roof is in good condition. A major snow event occurred prior to the site visit and large volumes of snow now surround the building where it has slid off the roof. (See figures 129 & 130) No eavestroughs are present and the main building.

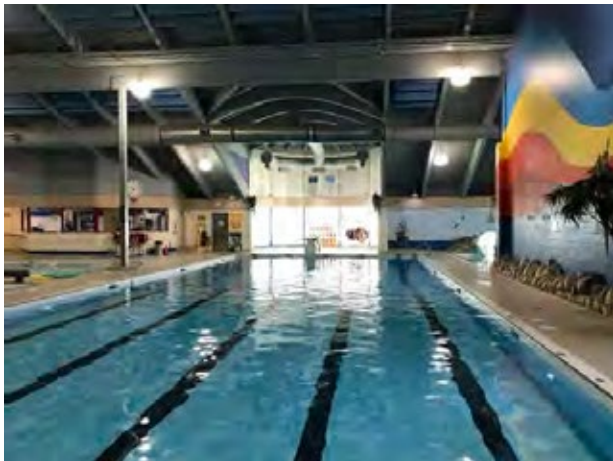
FIGURE 141

Hot tub, lane pool, kid pool, and slide landing pool are in good conditions. (See figures 141, 142, 143 & 144)

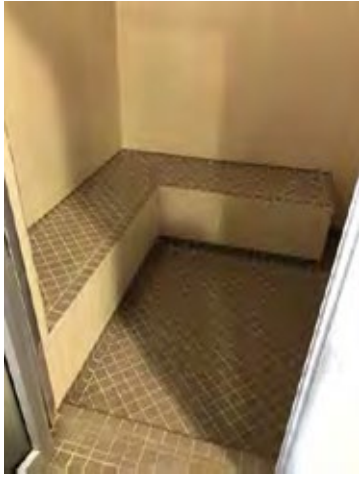
FIGURE 145

The sauna has wood paneling on the walls and ceiling is in good condition. (See figure 145) A glass window views onto the hot tub.

Sauna was recently renovated and is in good condition.

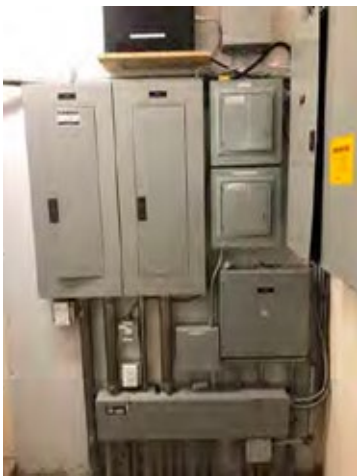
FIGURE 149

Electrical panels are located off the lobby. No concerns were noted with the current panel size or facility use requirements. (See figures 149 & 150)
